Due by: 28/02/2019		Visit Date: 11 Feb 2019	
Site address	Church Litten, Newport		
Visit Officer	JW		
Application Type	TPO not applicable	CA - Newport	
Application reference no: TW-0460-18			
<p>Site Notes: There has been one previous notification of work to this tree in January 2008, which was to reduce the crown of the tree where it overhangs the road. This work was carried out in the same year.</p> <p>The tree is located on the south western corner of Church Litten Park approximately six metres from Medina Avenue, which is a busy main road. The tree is adjacent to a pedestrian access point to the park from which a footpath leads north into the town centre under the crown of the tree, approximately one metre from its trunk. The crown spread of the tree overhangs the park, Medina Avenue and the recreation ground of Node Hill 6th form campus.</p> <p>The nearest properties are on the southern side of Medina Ave approximately 15 metres from the tree.</p> <p>The tree is owned by the Isle of Wight Council, and is on council-owned land. Therefore, an independent opinion on the condition of the tree was sought from Andrew Southcott, an independent arboricultural consultant. His findings

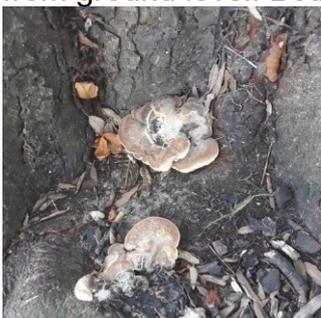
Inspection findings: The tree was initially inspected by the council tree officer on the 17 September 2018, at which time it was found that the crown had died back in approximately 25% of its volume, this being predominantly in the upper crown, leaving large sections of dead wood hanging over the foot path below. Two forms of fungi were found in the trunk of the tree. Meripilus giganteus was seen around 30% of the base of the trunk, and Ganoderma sp. Fungi found approximately three metres from ground level. Both these fungi cause rot in trees.

The Meripilus is white rot fungi that removes the cellulose and pectin from the wood and generally causes decay in the host tree roots. Due to the manner of decay the wood will split and fracture reducing the structural stability of the tree and the roots that support it. A further symptom of this fungi is die back in the crown of the tree, which is due to the slow decline in the roots reducing the

level of water and nutrients reaching the crown.

Treatment: There is no form of treatment for pathogens such as Meripilus and Ganoderma and it is not possible to prune the infected areas out of the tree without the removal of the tree. It is unlikely that the tree will prevent the spread of decay, as Horse chestnut are poor at compartmentalising areas of fungal infection and put up little defence to the spread of the pathogen throughout large areas of the tree, ultimately causing its collapse and demise.

Recommendations: The independent arboricultural assessment recommends the tree is felled due to the scale of fungal infection and the danger this presents to the surrounding area. He does consider the possibility of reduction of the tree but feels this would not fully address the risk the tree presents, and the tree would still require removal in due course.

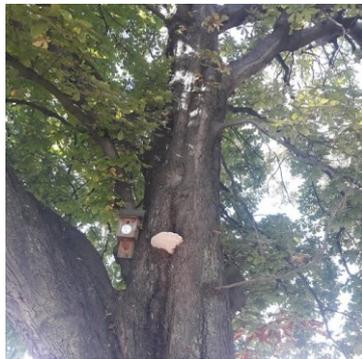
The Ganoderma is a heart rot fungus that causes the delignification of the wood making it spongy, with less rigidity causing it to become weaker and with less ability to carry heavy loads making the infected area prone to collapse in the later periods of infection. It is noted that the tree has also got a pocket of decay that extends from the ground to the fungal bracket. The full extent of this decay is unknown but from probing it is seen that this is of significant size.
