Heritage Assets at Risk in the Medina Valley

January 2014

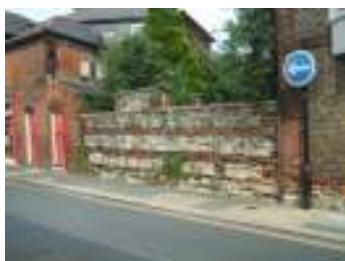
<i>Site Name:</i>	Cement Chamber Kiln (former Medina Cement Works, Stag Lane, Newport	The original kiln lies inside the concrete shroud of later adaptations.
<i>Designation:</i>	Locally Listed	
<i>Condition:</i>	Poor	
<i>Occupancy:</i>	N/A	
<i>Risk / Priority:</i>	1 / A	
<i>Ownership:</i>	IWC	
<i>Significance:</i>	19 th and 20 th century cement works including partial remains of a 19 th century brick chamber kiln. Owned by Charles Francis, who was associated with technical developments in cement production. It is reputed that the Medina Cement produced here was used in Osborne House.

- 9.3 The Cement Chamber Kiln at Stag Lane is identified as being a priority, due to its immediate risk of further rapid deterioration or loss of fabric with no solution being agreed. The surrounding area has had a long history associated with cement works and associated uses. Most of the structures previously connected with the cement industry on the site have been cleared, however remnants of this old lime kiln dating back to the 19th century remain. Due to the overgrown nature of the site the kiln could only be viewed from distance during the survey, but as stated in its Local List nomination it is known in part due to previous surveys undertaken by the council, to be very dilapidated. It is thought the original kiln lies inside the concrete shroud of later adaptations. It is adjacent to the new Vestas development on the River Medina.

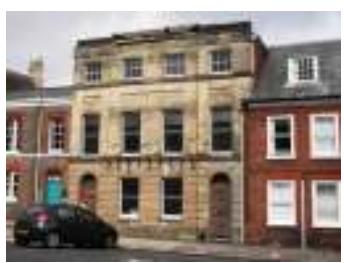
Site Name:	11, 13 & 17 Castle Road, Newport	As a group listing No's 11 & 17 appear to be structurally sound and well maintained
Designation:	Grade II, CA	
Condition:	Fair	but No. 13 is suffering from a lack of maintenance and appears to be unoccupied.
Occupancy:	Part Occupied	
Risk / Priority:	2 /C	
Ownership:	Unknown/Unregistered owner	
Significance:	Constructed late 18 th / early 19 th century, cement rendered with gable end slate roofs. This grade II listed building forms part of a group within the Carisbrooke Road Character Area of Newport Conservation Area. Terrace housing is important to the character of this area and these properties add to the long views of the artisan terraces along Castle Road.

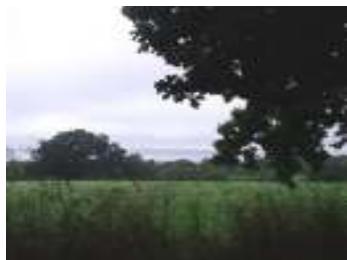
<i>Site Name:</i>	Carisbrooke Cemetery, Whitcombe Road, Carisbrooke	The cemetery is accessed through an impressive entrance drive. The south-western area appears neglected with monuments in poor condition and overgrown by vegetation. The Lodge and its curtilage, whilst outside the defined area of the local list entry, are an important and highly visible part of the historic designed cemetery landscape.
<i>Designation:</i>	Locally Listed	
<i>Condition:</i>	Fair	
<i>Vulnerability:</i>	Medium	
<i>Risk / Priority:</i>	2 / F	
<i>Ownership:</i>	IWC

<i>Significance:</i>	One of the Island's oldest and largest public cemeteries, which contains several locally important monuments. The cemetery has a Gate Lodge, Chapels and a Gateway which has recently been rebuilt so the building features are fairly complete.
----------------------	--
